# Pinal County Airpark

## Electrical Infrastructure Study

February 1, 2013

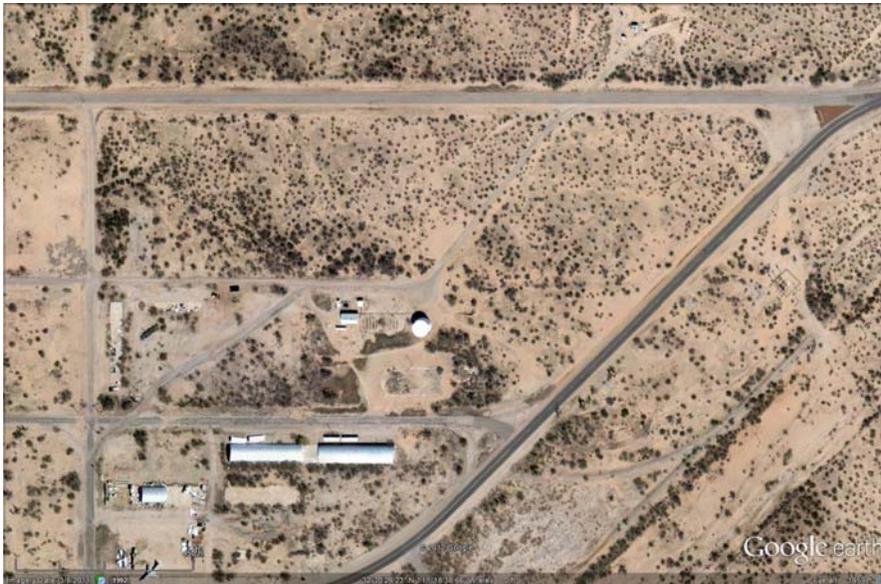
### 5.04 - QUONSET P STREET

No major issues were identified at this location and no immediate deficiencies were noted.

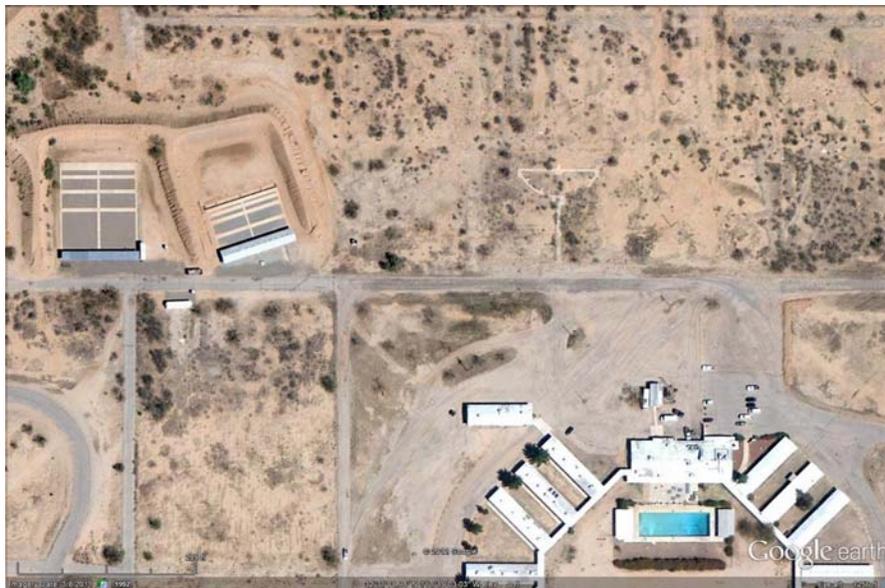
### 5.09 - SHOOTING RANGE

The enclosure that houses the pole mounted transformer, which is set on the ground, is made of plywood and is deteriorating and weathering. There is not enough clearance to properly service the transformer. The pole mounted transformer should not be used in this location.

The transformer and the enclosure should be removed. A new pad-mount transformer should be installed in this location where all of the wiring can be placed in an approved enclosure to remove the liability of the possibility of accidental contact with deadly medium Voltage wiring. This installation is in violation of the NEC and with accepted practices and standards. It also poses health and life safety issues and needs to be corrected immediately.

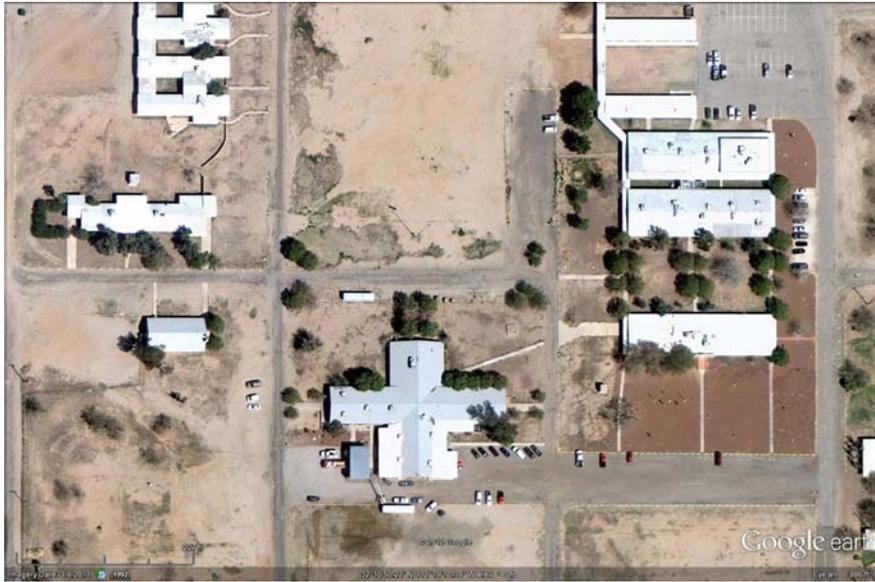
### 5.24 - FIRE STATION & HUMAN RESOURCE BUILDING ELECTRICAL SYSTEM

marks. This is one of the most dangerous installations at Pinal County Airpark. The 100 KVA, 4160 Volt pole mount transformers set on the ground that are enclosed in the electrical room of the Fire Station are a hazard. The installation has exposed wiring, the improper use of a pole mounted transformer in an electrical room, and it does not have the proper amount of working clearance for the medium voltage equipment that it houses. The room is electrically charged and the amount of dust makes this area very dangerous.

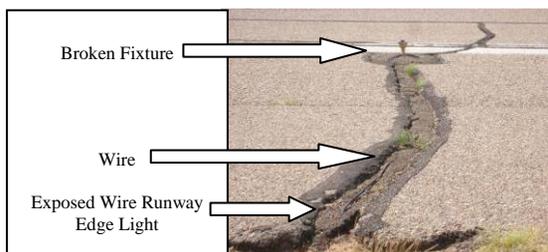
Exposed Cable 5000 Volt

The edge lights should be replaced and relocated in accordance with the FAA AC and the NEC requirements.

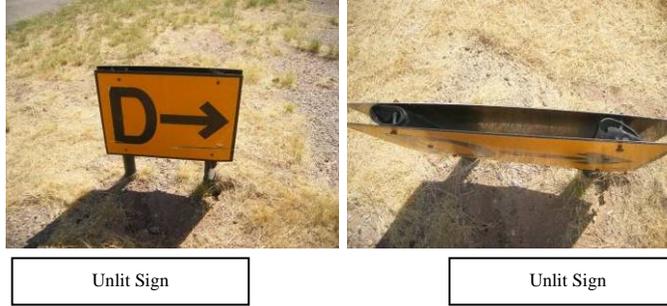
Unlit Sign
