# Pinal County Airpark

## Electrical Infrastructure Study

February 1, 2013

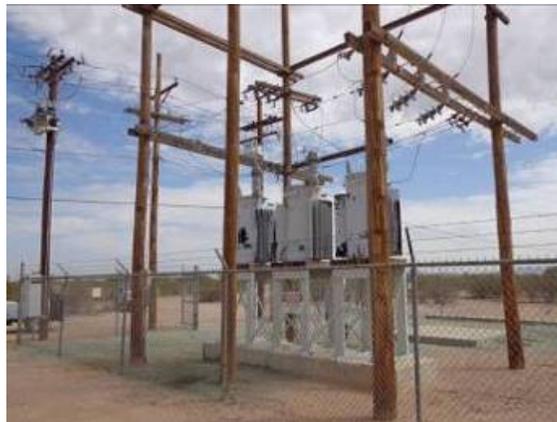
The inspection started at the Trico Sub-Station located on the south side of the main road after entering the security gate. The Trico transmission lines come in from the utility TGEL&P (TRICO). At the substation there are two (2) main lines that come into the Airpark on a 4160 Volt Overhead (OH) Line which is located closest to the road and a 25 kV Overhead Line. These two lines are metered by the Utility at the substation.

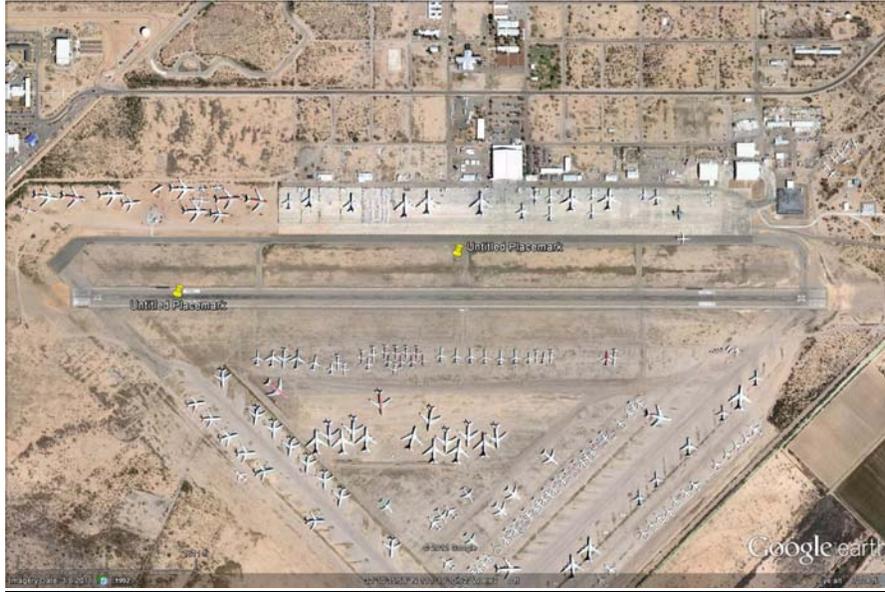
## Section 8: AIRFIELD ELECTRICAL SYSTEM

The airfield lighting and signage at the Pinal County Airpark was evaluated to determine the status of the airfield electrical system, to identify the deficiencies in the system, and to make recommendations on how to correct the deficiencies to insure the reliable safe operation of the airfield electrical system in the future.

The system was originally installed in 1942 as a military airfield. The system, though still operational, has reached and surpassed its expected life. Even though there has been ongoing maintenance, the basic system is still 70 years old. The airfield electrical vault is very antiquated and still has the old style knob and tube wiring mounted around the ceiling. The constant current regulator (CCR) is newer yet it still dates back to the 1960s. The controls are a combination of new circuitry and old enclosure and contacts. The airfield cable is installed from the airfield electrical vault to the airfield manhole out on the airfield. From the manhole, the cable runs for some distance inside conduits then changes to direct burial the balance of the way to the airfield signs and edge lights. In the infield and along the shoulders of the runway, the direct buried cable is exposed to the elements and subject to damage.

7. The Airfield lighting system needs to be totally replaced starting with the 4150 Volt transformer and old knob and tube wiring inside the airfield electrical vault to the 5kV cable exposed on the infield of the airfield.

- b. Airfield Electrical Vault – Replacement of the constant current regulators, airfield lighting controls, and all associated electrical equipment with updated, modern FAA certified equipment, approximately \$120,000.00 in estimated construction costs.
  - c. Airfield Lighting – Replacement of all wiring, conduits, and lighting for the airfield, approximately \$434,000.00 in estimated construction costs.
  - d. Airfield Guidance Signage – Replacement of the airfield signage to bring it into compliance with the FAA standards, approximately \$171,000.00 in estimated construction costs.
3. See Section 9.02 for a total site estimates per area’s described including design service, refurbish costs and maintenance.
