**GEOTECHNICAL EVALUATION
HUNT HIGHWAY
GARY ROAD TO BELLA VISTA ROAD
PINAL COUNTY, ARIZONA
PINAL COUNTY PROJECT NO. 6621173**

Subject: Geotechnical Evaluation
Hunt Highway; Gary Road to Bella Vista Road
Pinal County, Arizona
Pinal County Project No. 6621173

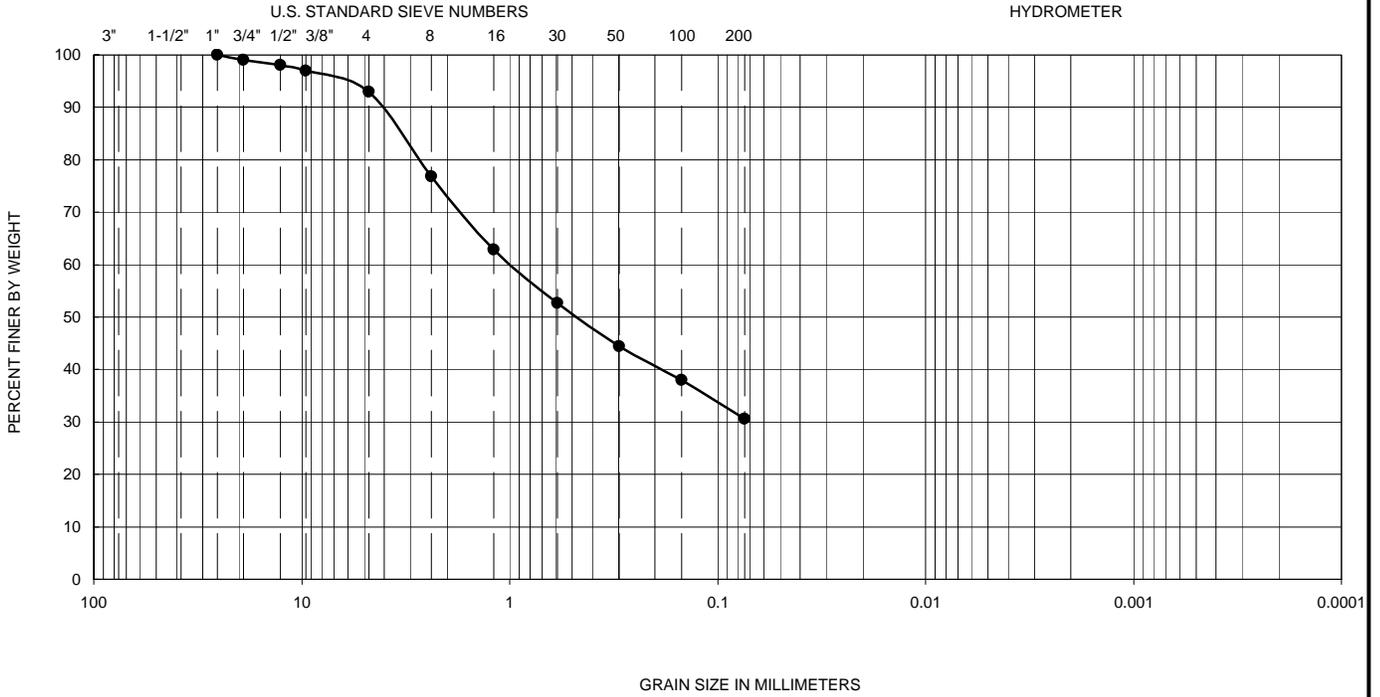
Ninyo & Moore		GRADATION TEST RESULTS	FIGURE	
PROJECT NO.	DATE		HUNT HIGHWAY GARY ROAD TO BELLA VISTA ROAD PINAL COUNTY, ARIZONA	B-1
601868003	1/14

Symbol	Hole No.	Depth (ft)	Liquid Limit	Plastic Limit	Plasticity Index	D ₁₀	D ₃₀	D ₆₀	C _u	C _c	Passing No. 200 (%)	U.S.C.S
●	B-1	1.0-5.0	--	--	NP	--	--	--	--	--	31	SM

PERFORMED IN GENERAL ACCORDANCE WITH ASTM D 422

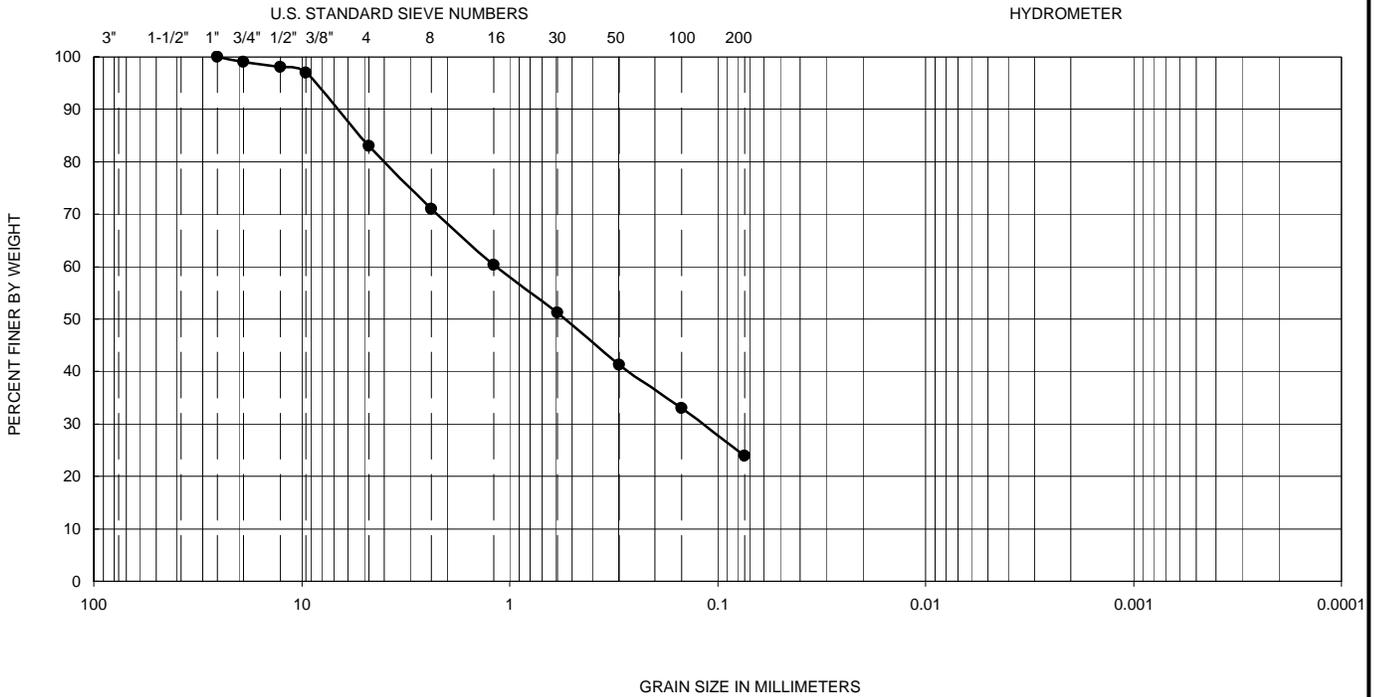
Ninyo & Moore		GRADATION TEST RESULTS	FIGURE	
PROJECT NO.	DATE		HUNT HIGHWAY GARY ROAD TO BELLA VISTA ROAD PINAL COUNTY, ARIZONA	B-2
601868003	1/14

Symbol	Hole No.	Depth (ft)	Liquid Limit	Plastic Limit	Plasticity Index	D ₁₀	D ₃₀	D ₆₀	C _u	C _c	Passing No. 200 (%)	U.S.C.S
●	B-4	1.0-4.3	--	--	NP	--	--	--	--	--	24	SM

PERFORMED IN GENERAL ACCORDANCE WITH ASTM D 422

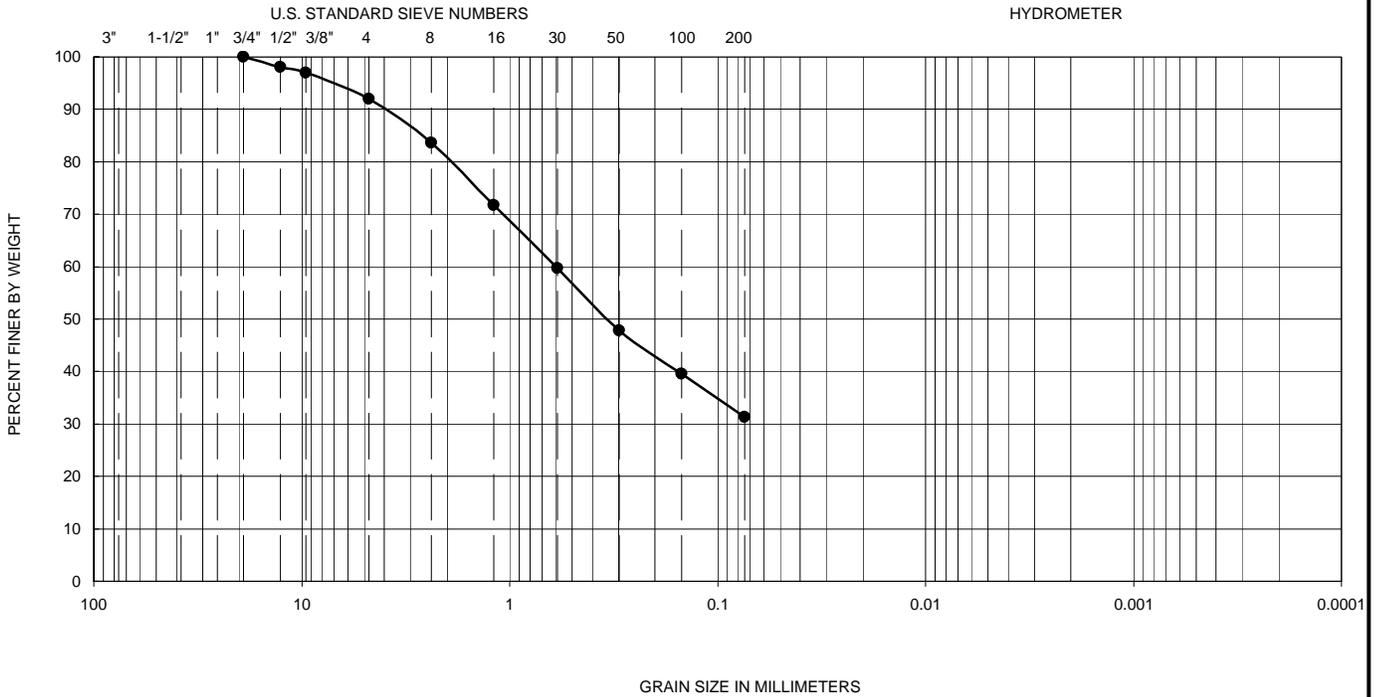
Ninyo & Moore		GRADATION TEST RESULTS	FIGURE
PROJECT NO.	DATE		B-3
601868003	1/14	HUNT HIGHWAY GARY ROAD TO BELLA VISTA ROAD PINAL COUNTY, ARIZONA

Symbol	Hole No.	Depth (ft)	Liquid Limit	Plastic Limit	Plasticity Index	D ₁₀	D ₃₀	D ₆₀	C _u	C _c	Passing No. 200 (%)	U.S.C.S
●	B-7	1.0-3.9	--	--	NP	--	--	--	--	--	31	SM

PERFORMED IN GENERAL ACCORDANCE WITH ASTM D 422

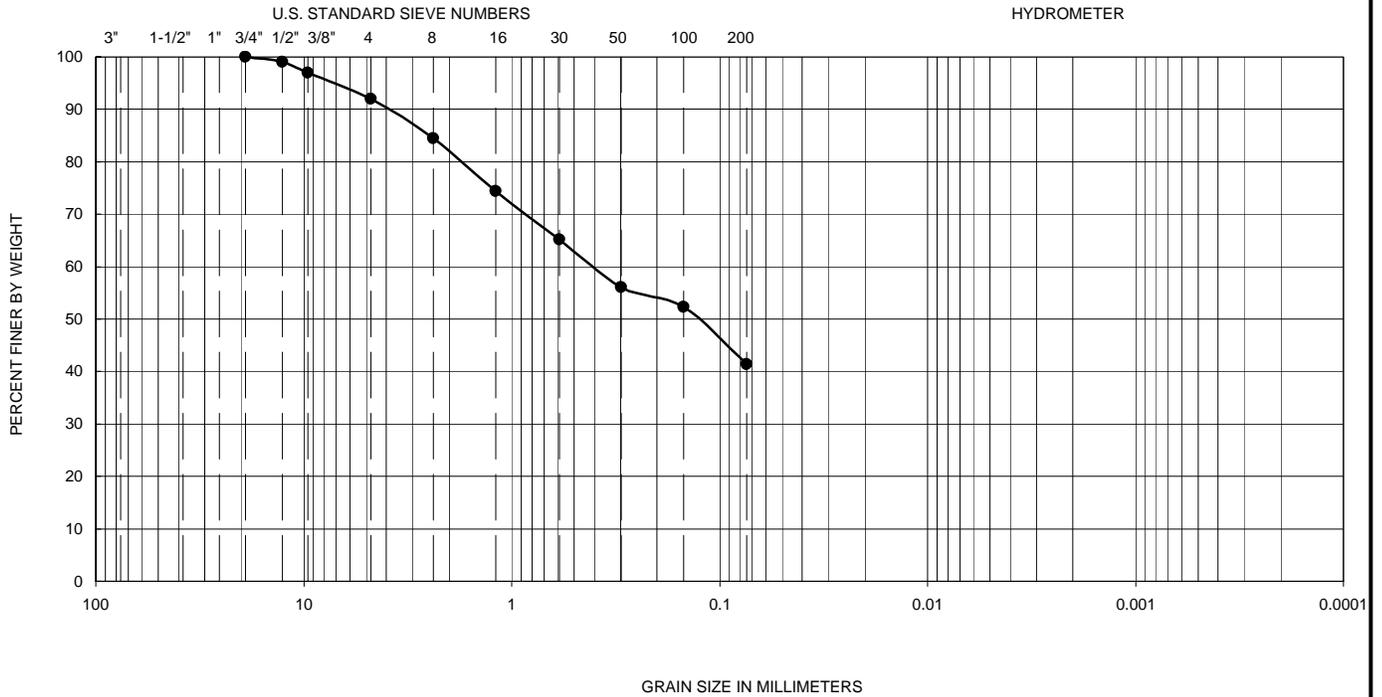
Ninyo & Moore		GRADATION TEST RESULTS	FIGURE
PROJECT NO.	DATE		B-4
601868003	1/14	HUNT HIGHWAY GARY ROAD TO BELLA VISTA ROAD PINAL COUNTY, ARIZONA

Symbol	Hole No.	Depth (ft)	Liquid Limit	Plastic Limit	Plasticity Index	D ₁₀	D ₃₀	D ₆₀	C _u	C _c	Passing No. 200 (%)	U.S.C.S
●	B-10	1.0-4.9	--	--	NP	--	--	--	--	--	41	SM

PERFORMED IN GENERAL ACCORDANCE WITH ASTM D 422

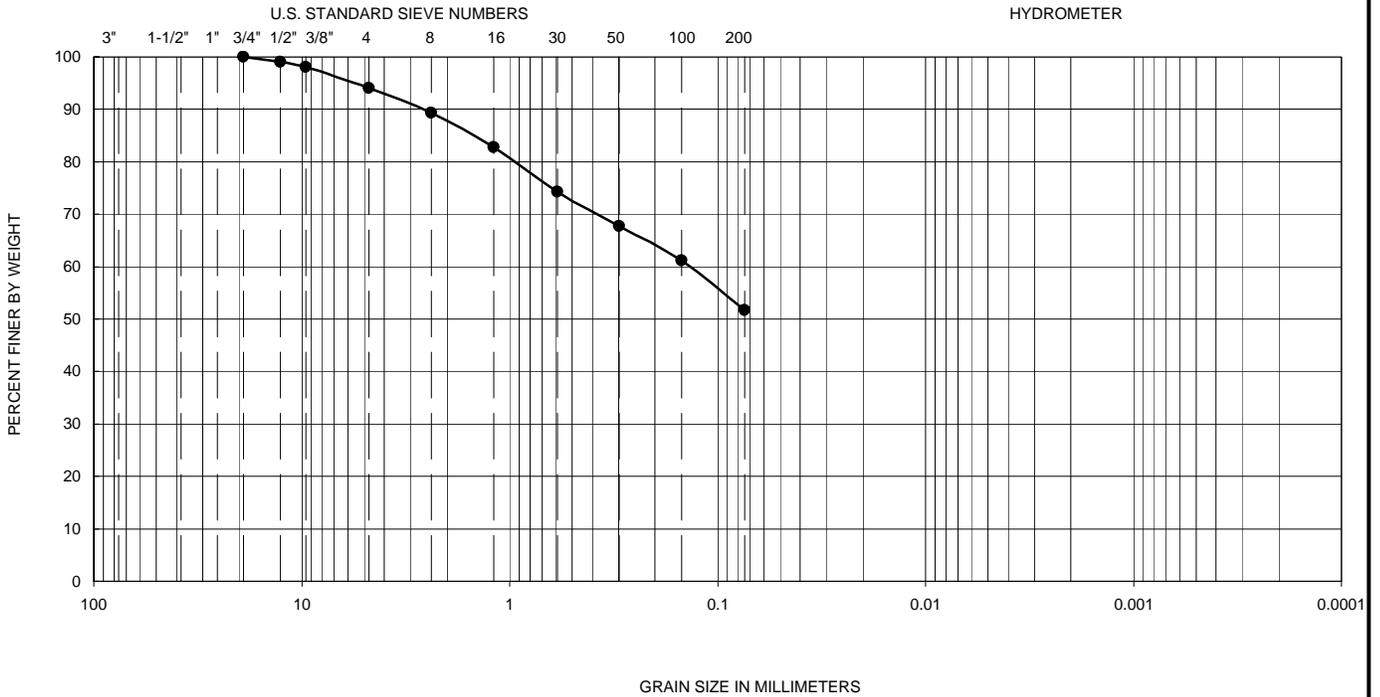
Symbol	Hole No.	Depth (ft)	Liquid Limit	Plastic Limit	Plasticity Index	D ₁₀	D ₃₀	D ₆₀	C _u	C _c	Passing No. 200 (%)	U.S.C.S
●	B-13	1.0-5.0	45	19	26	--	--	--	--	--	52	CL

PERFORMED IN GENERAL ACCORDANCE WITH ASTM D 422

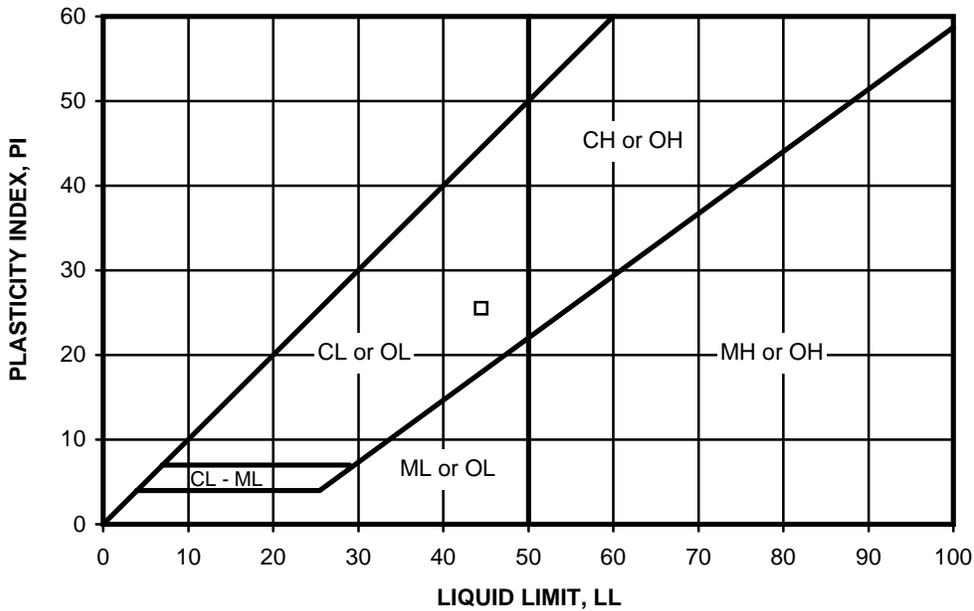
<i>Ninyo & Moore</i>		ATTERBERG LIMITS TEST RESULTS	FIGURE
PROJECT NO.	DATE	HUNT HIGHWAY	B-6
601868003	1/14	GARY ROAD TO BELLA VISTA ROAD	
		PINAL COUNTY, ARIZONA

SYMBOL	LOCATION	DEPTH (FT)	LIQUID LIMIT, LL	PLASTIC LIMIT, PL	PLASTICITY INDEX, PI	USCS CLASSIFICATION (Fraction Finer Than No. 40 Sieve)	USCS (Entire Sample)
●	B-1	1.0-5.0	--	--	NP	ML	SM
■	B-4	1.0-4.3	--	--	NP	ML	SM
◆	B-7	1.0-3.9	--	--	NP	ML	SM
○	B-10	1.0-4.9	--	--	NP	ML	SM
□	B-13	1.0-5.0	45	19	26	CL	CL

NP - INDICATES NON-PLASTIC

PERFORMED IN GENERAL ACCORDANCE WITH ASTM D 4318

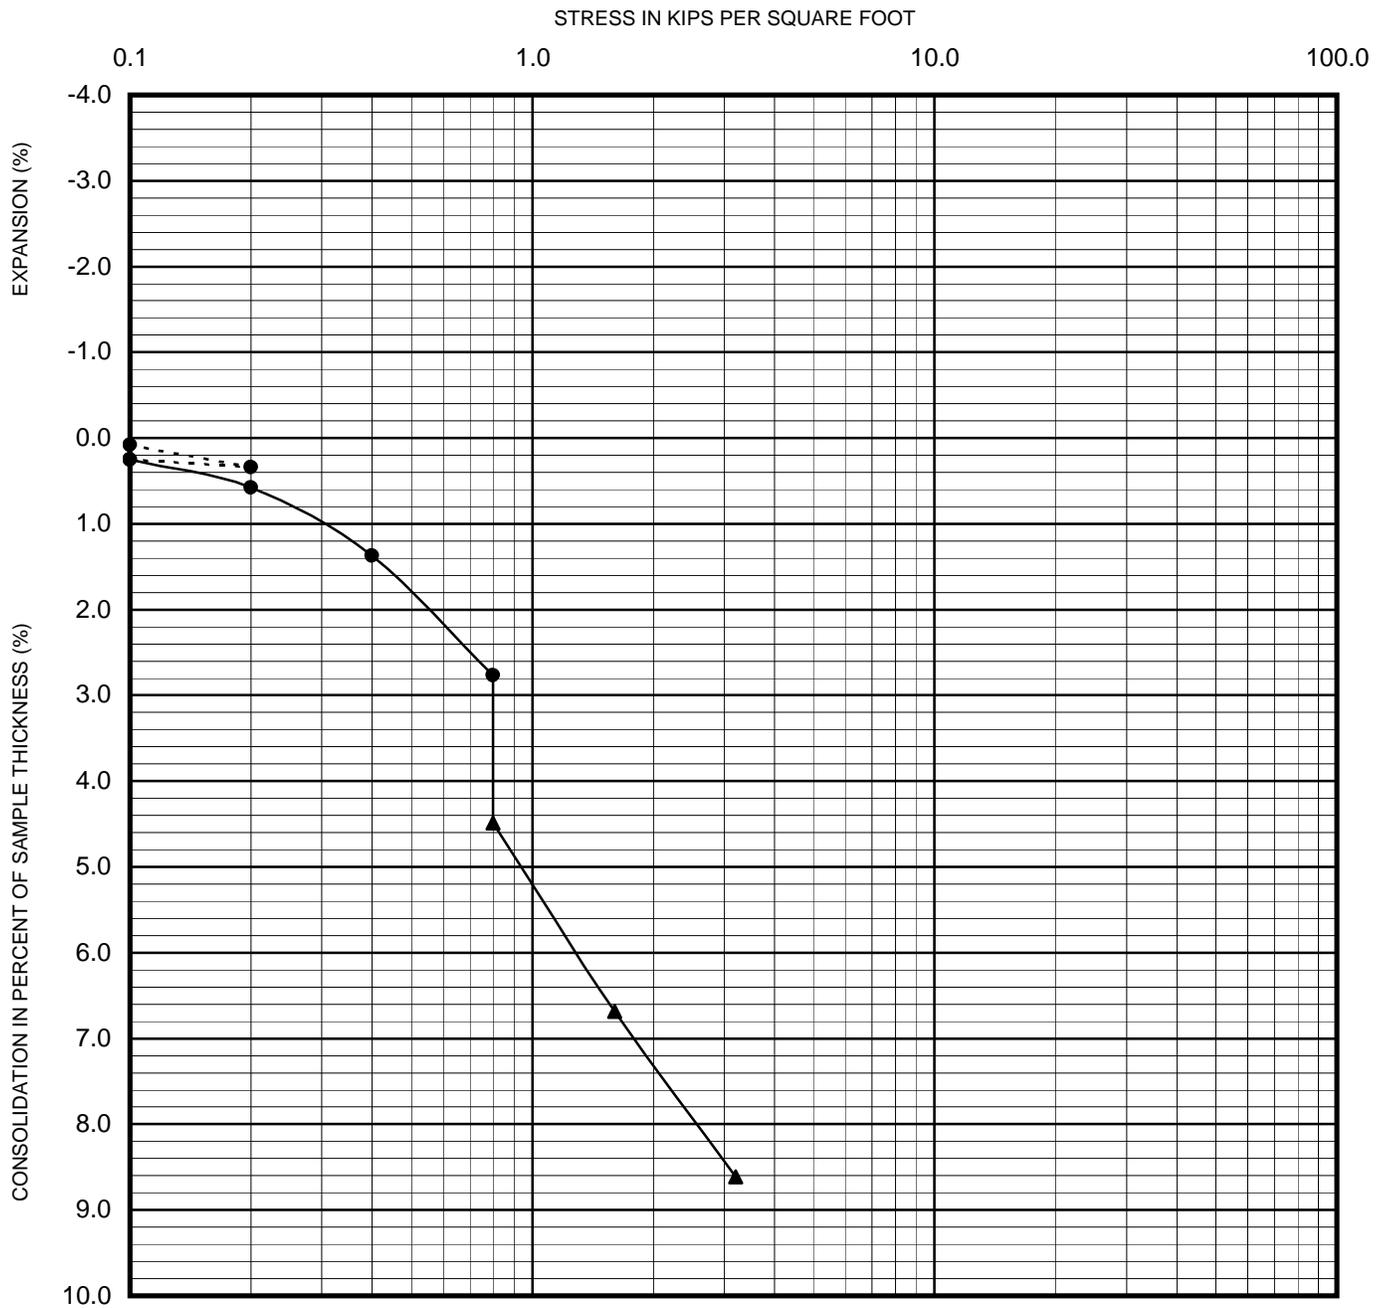
Ninyo & Moore		CONSOLIDATION TEST RESULTS	FIGURE
PROJECT NO.	DATE		B-7
601868003	1/14	HUNT HIGHWAY GARY ROAD TO BELLA VISTA ROAD PINAL COUNTY, ARIZONA

--●---	Seating Cycle	Sample Location	B-3
—●—	Loading Prior to Inundation	Depth (ft.)	1.0-2.5
—▲—	Loading After Inundation	Soil Type	SM
-▲-	Rebound Cycle

PERFORMED IN GENERAL ACCORDANCE WITH ASTM D 2435

Consolidation tests were performed on selected relatively undisturbed soil samples in general accordance with ASTM D 2435. The samples were inundated during testing to represent adverse field conditions. The percent of consolidation for each load cycle was recorded as a ratio of the amount of vertical compression to the original height of the sample. The results of the tests are summarized on Figures B-7 and B-8.

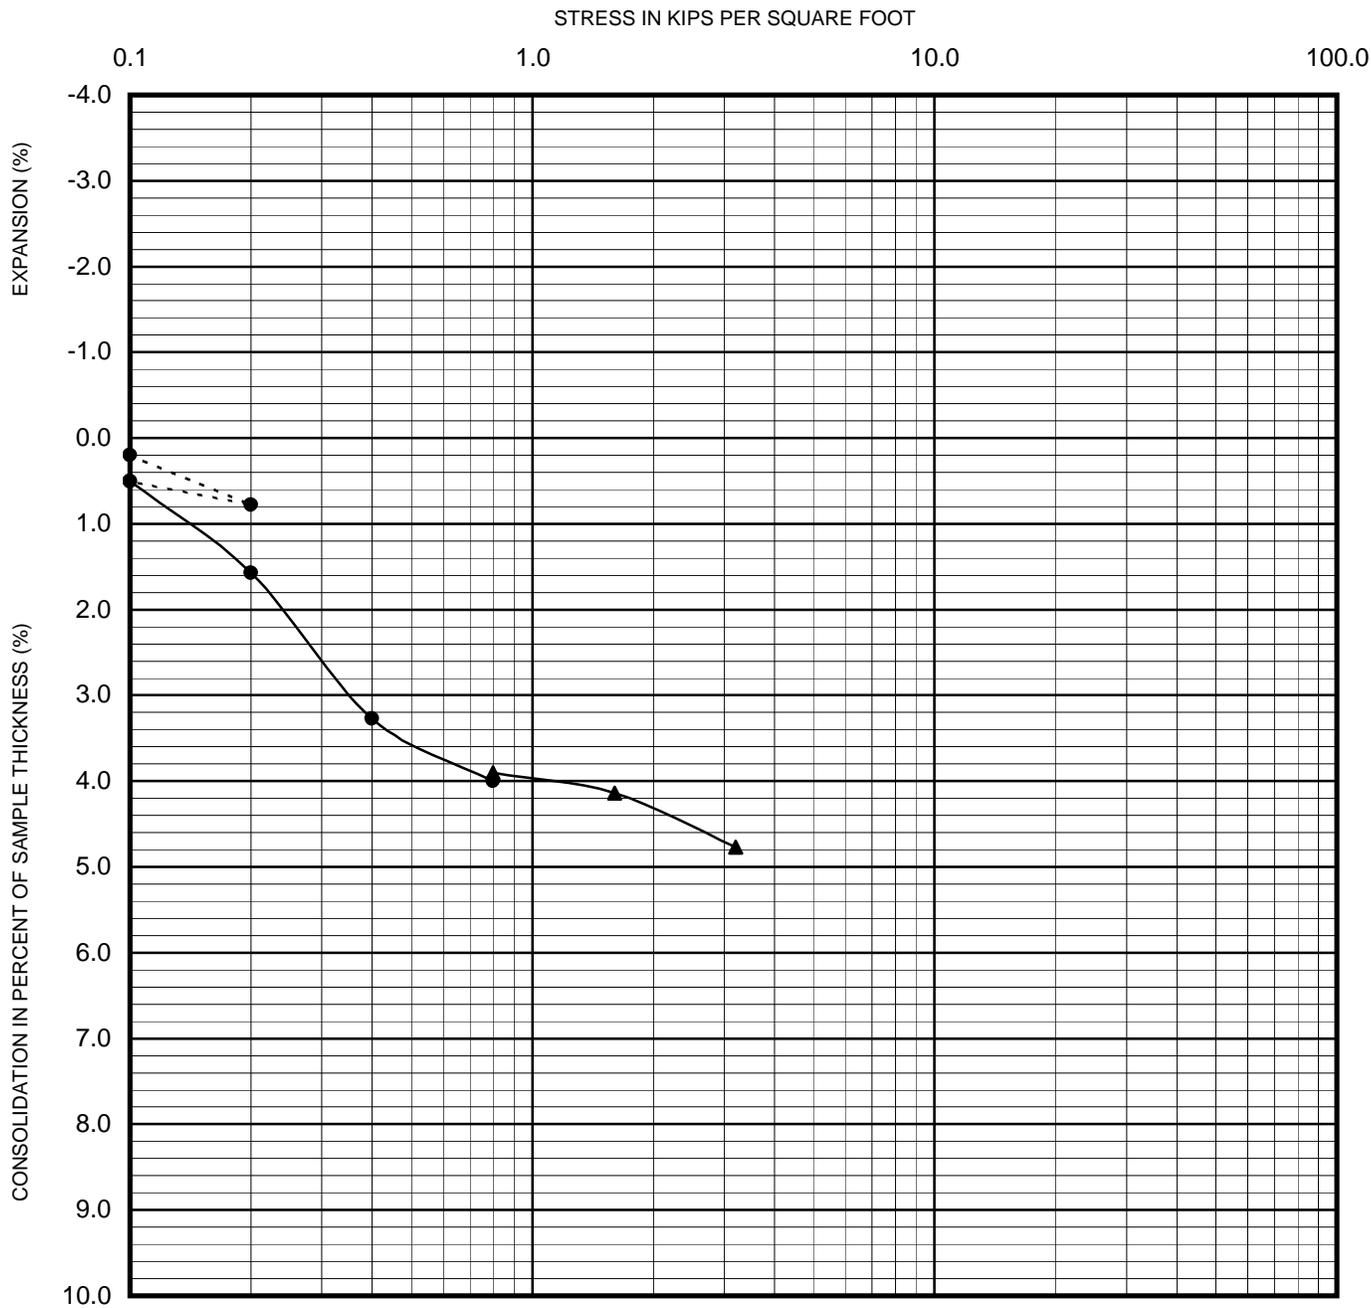
Ninyo & Moore		CONSOLIDATION TEST RESULTS	FIGURE B-8
PROJECT NO.	DATE		
601868003	1/14	HUNT HIGHWAY GARY ROAD TO BELLA VISTA ROAD PINAL COUNTY, ARIZONA

---●--- Seating Cycle Sample Location B-13
 —●— Loading Prior to Inundation Depth (ft.) 1.0-2.5
 —▲— Loading After Inundation Soil Type CL
 -▲- Rebound Cycle

PERFORMED IN GENERAL ACCORDANCE WITH ASTM D 2435

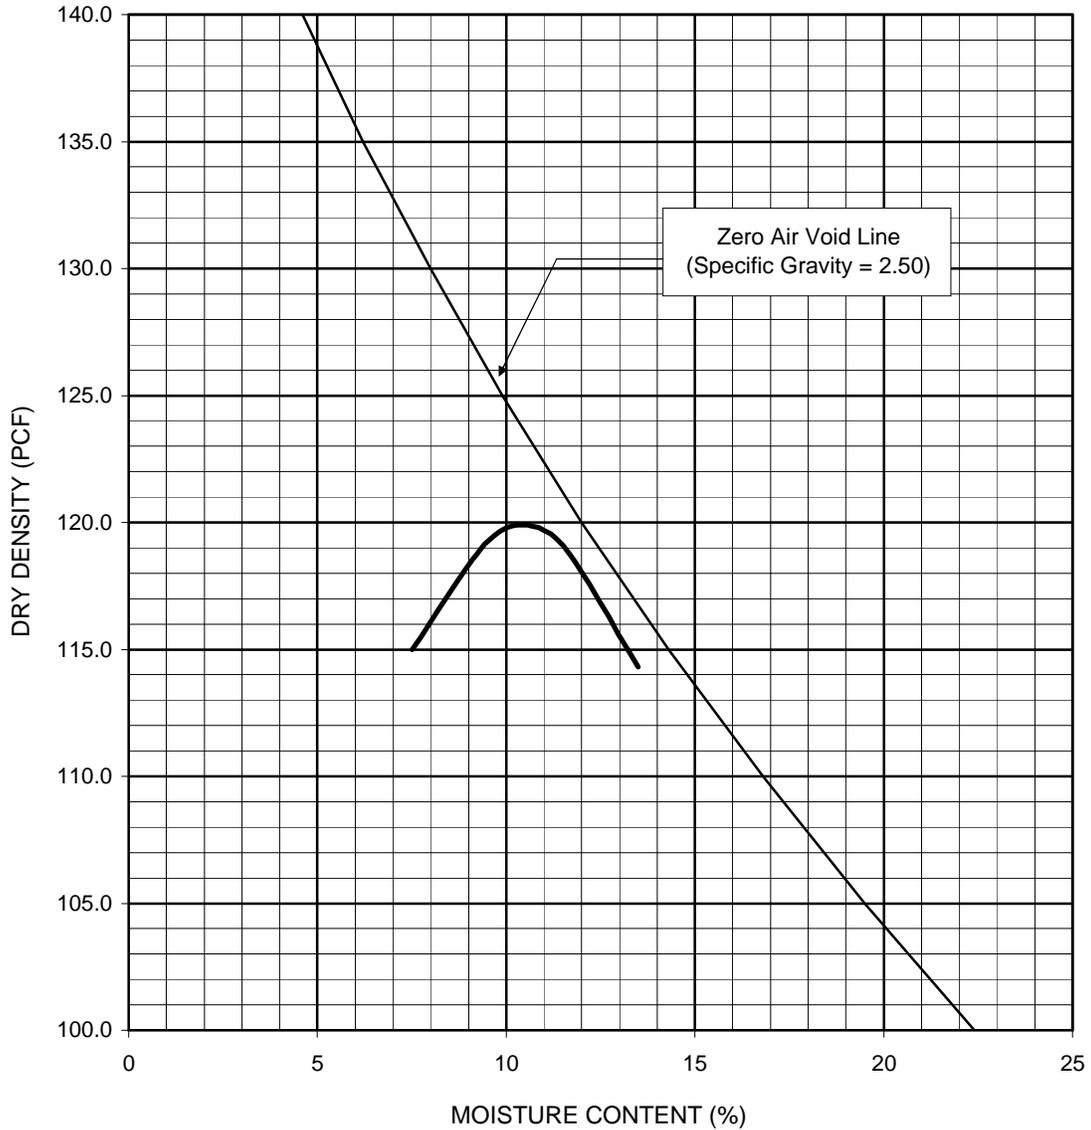
Sample Location	Depth (ft)	Soil Description	Maximum Dry Density (pcf)	Optimum Moisture Content (%)
B-5	1.0-5.0	CLAYEY SAND	119.9	10.3
Dry Density and Moisture Content Values Corrected for Oversize (ASTM D 4718-87)			123.0	9.0

PERFORMED IN GENERAL ACCORDANCE WITH ASTM D 1557 ASTM D 698 METHOD A B C

The maximum dry density and optimum moisture content of a selected representative soil sample was evaluated in general accordance with ASTM D 698. The result of this test is summarized on Figure B-9.
